[Receiver Considerations for Jupiter](#)

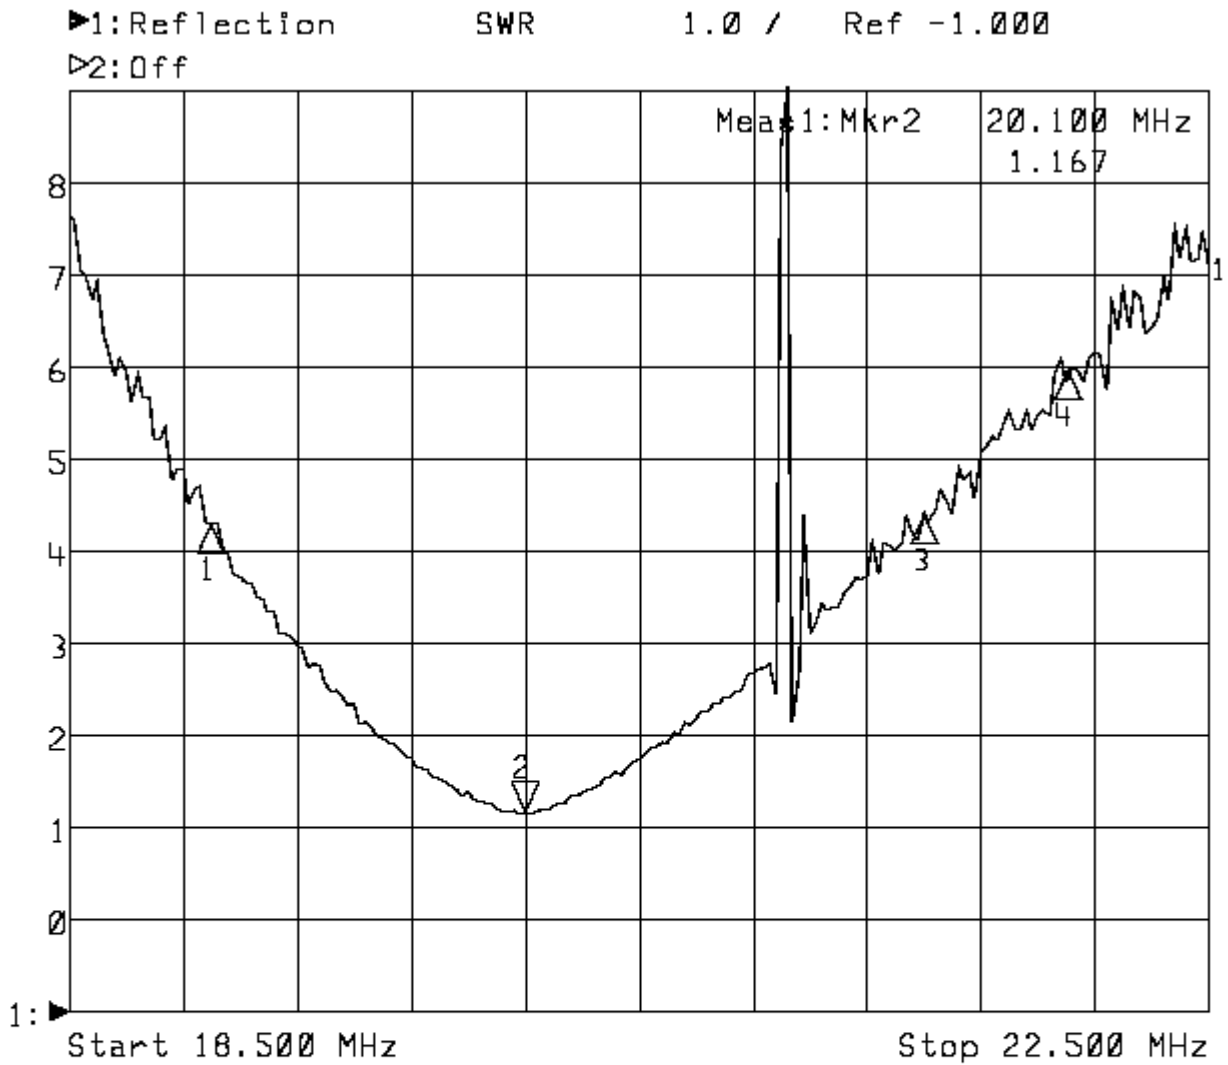
1: Mkr (MHz)	2: Mkr (MHz)	dB
1: 19.0000	4.308	
2> 20.1000	1.167	
3: 21.5000	4.409	
4: 22.0000	5.982

The sudden rise in VSWR at ~21MHz is because of the LO leakage at RF port.
